**EMERGENCY SPILLWAY PERFORMANCE,
UPPER RED ROCK CREEK WATERSHED,
OKLAHOMA**

ARS-S-108

May 1976

By W. O. Ree¹

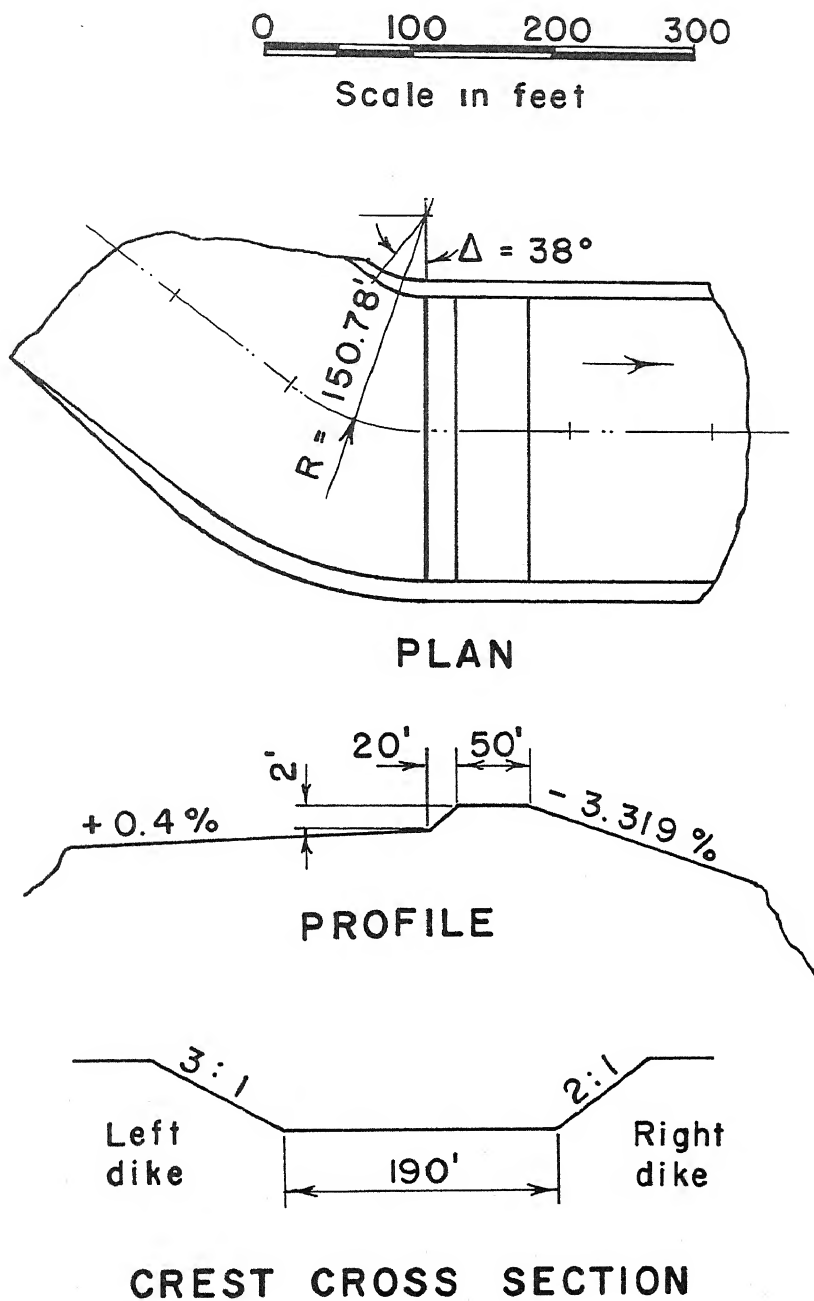
FIGURE 2.—Emergency spillway dimensions, site 24.

The emergency spillway is an earth channel around the right end of the dam (fig. 2). It was excavated in the red clay and shale of the site, topsoiled to a depth of 6 inches, and planted with ber-

mudagrass. At the time of the survey the noneroded area of the spillway had a poor stand of short, heavily grazed bermudagrass and a scattering of broomweed. The flow retardance was judged to be class E, based on the criteria in the Soil Conservation Service handbook.²

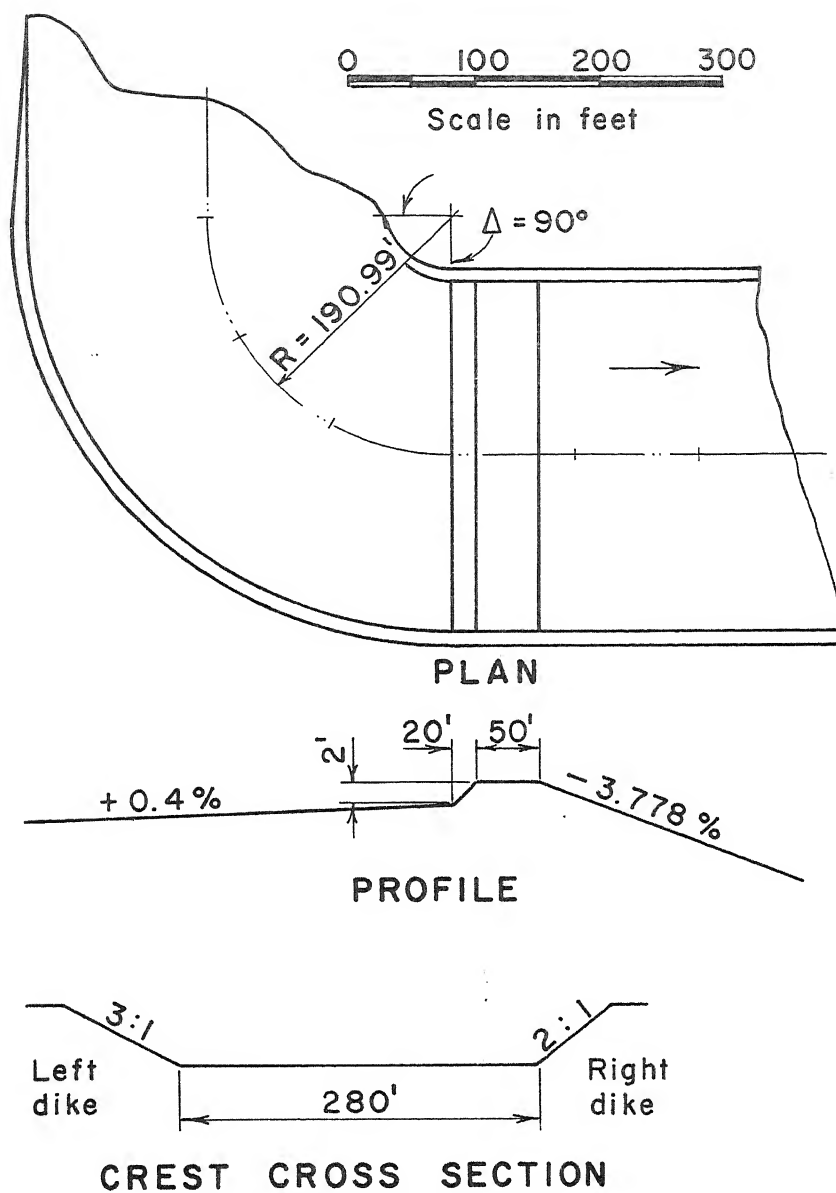
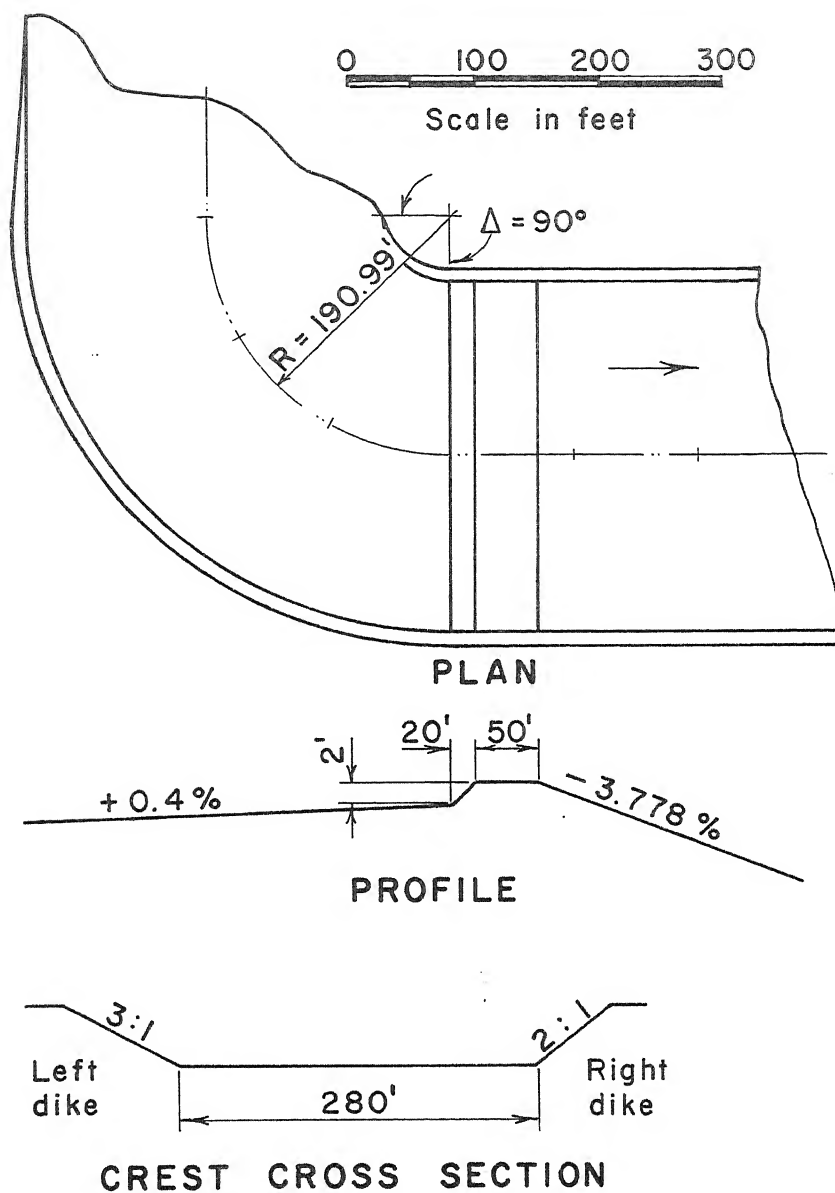
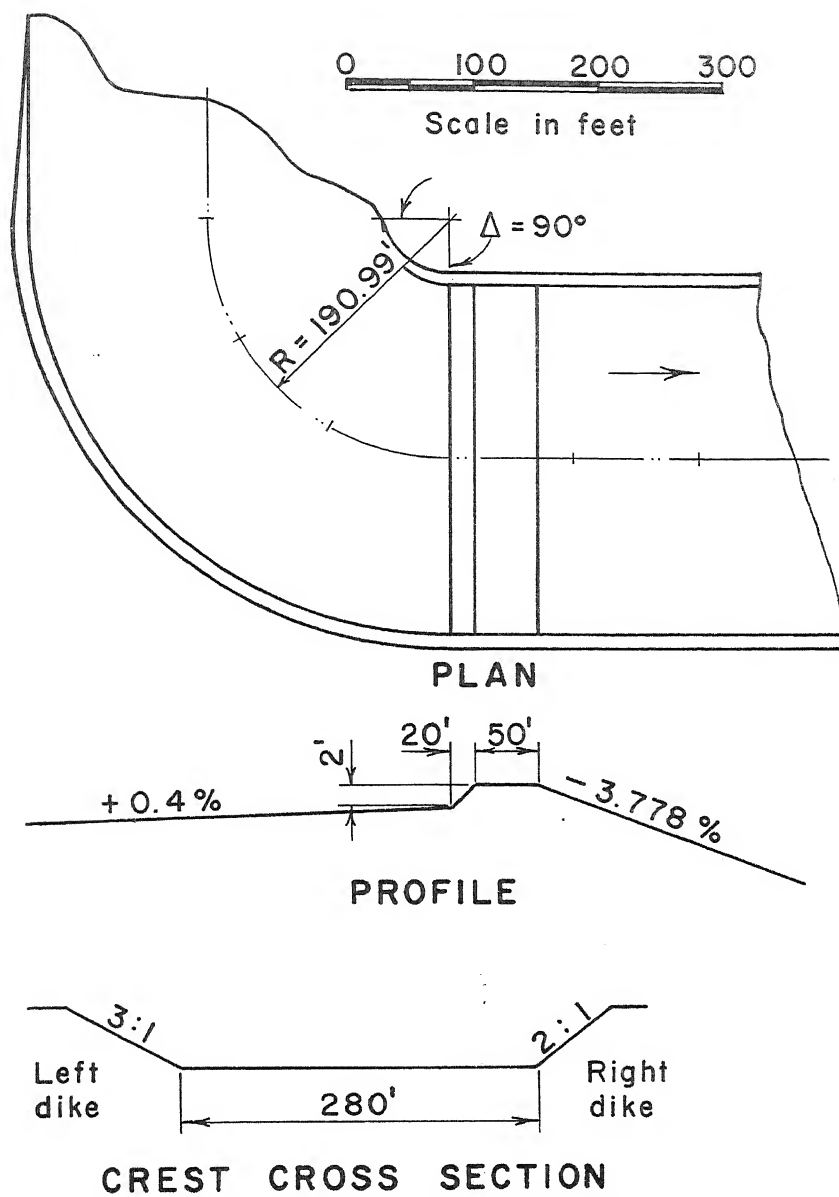
FIGURE 7.—Emergency spillway dimensions, site 25.

The emergency spillway is at the right end of the dam. Its dimensions are shown in figure 7. A minimum of 6 inches of topsoil had been placed on the spillway surface after excavation and shaping. At the time of the flood the spillway had a very uniform, good cover of bermudagrass, with a scattering of a short, fine-leaved grass and broomweed. The spillway had been grazed, and the grass was relatively short. Its flow retardance was estimated to be class E.

Runoff from the storm was sufficient to cause flow in the emergency spillway. The water surface elevation reached a maximum of 1.3 feet above the crest of the emergency spillway. The peak outflow rate for this head was estimated to be 767 cubic feet per second (by the procedure described in the presentation of the site 24 data). A water surface profile computation for a discharge of 767 cubic feet per second showed that the slope of the spillway was

The spillway was in excellent condition after the flood. Some slight erosion was evident about 20 feet downstream from the crest and about 40 feet in from the right bank (fig. 8). It is not known whether this eroded area was present before the flood or whether there had been a weak spot in the cover here. An overall view of the spillway is shown in figure 9.

The excellent condition of the spillway should be expected because the flow velocity of 5.6 feet per second is below a suggested permissible velocity of 8 feet per second for a bermudagrass cover on clay soil and slopes of less than 5 percent, as determined from the "Handbook of Channel Design for Soil and Water Conservation" (cited in footnote 2). Uniformity of cross section and cover and moderate grazing can also be given some credit for the fine performance of the spillway.

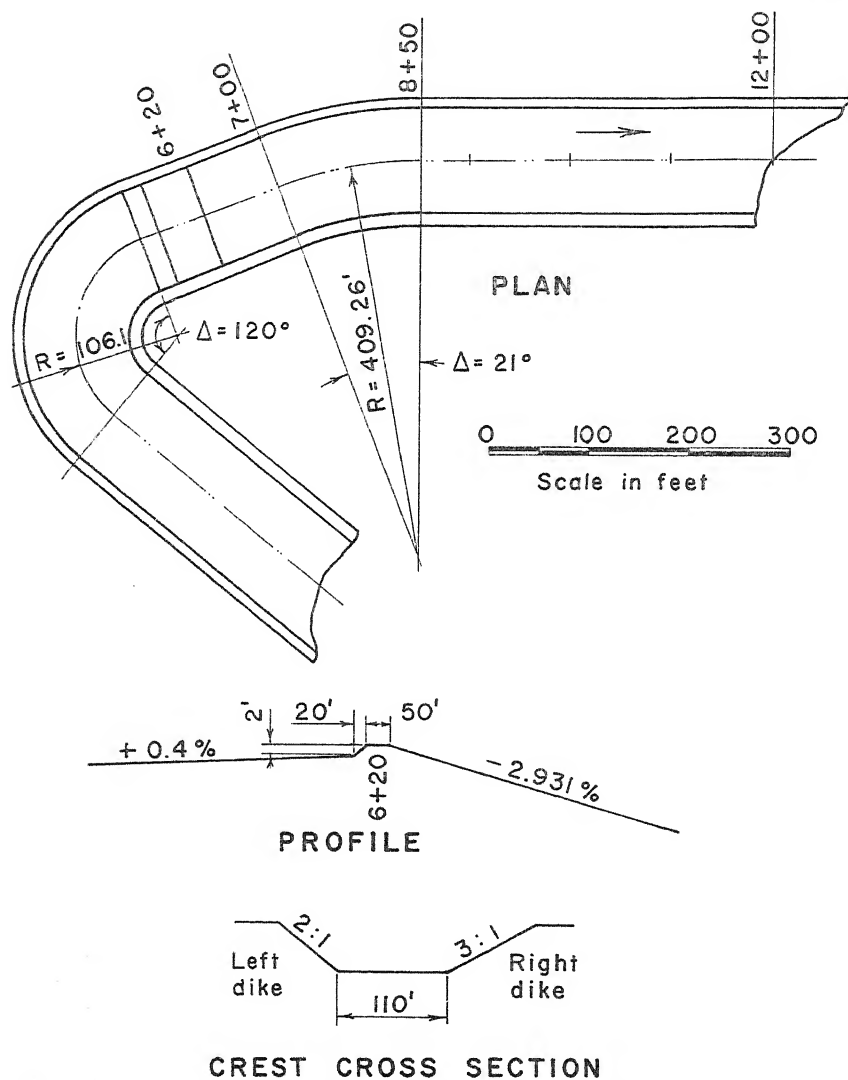
FIGURE 10.—Emergency spillway dimensions, site 30.

The emergency spillway is at the left end of the dam. Its dimensions are shown in figure 10. This spillway has two unusual characteristics. The crest is constructed in fill, probably not more than a foot or two deep, and there is a curve in the downstream reach of the spillway. Topsoil had been placed in the spillway to a depth of 6 inches and bermudagrass was established as a cover. At the time of the flood there was an excellent stand of bermudagrass on the crest and the upper part of the spillway. Toward the lower end of the downstream reach the grass cover was fair to good. The spillway had not been grazed prior to the flood. The overall flow retardance for the cover was estimated to be class C.

In the lower part of the downstream reach the flow tended to concentrate in the center of the spillway, where it is no longer flat bottomed, but is lower in the center so it can merge gradually into

Three general observations can be made about this spillway.

First, constructing a spillway in fill is not an acceptable practice and is resorted to only when it is the best alternative solution to a vexing location problem. I have seen only one other spillway with a portion constructed in fill, and this portion failed during a flood event by gulying to a depth of 5 feet. This experience supports the present practice of avoiding fill in the spillway. However, there may be some advantages to using fill in a spillway. The filled area

Third, every effort should be made to avoid placing curves or changes in alinement in steep channels because of the hydraulic disturbances they cause. However, in this case, a curve was the best solution to the location problem. Since the flow was not large enough to be greatly disturbed by the curve, a test of the effect of the curve on the stability of the spillway channel was not obtained during this event.

where the velocity is highest and where the gully starts. (It could eventually reach the center.) A level sill and a low drop structure at the terminal end of the spillway would eliminate the need for the deepening that threatens the stability of the spillway. This would be a practical solution only if the grass could be relied upon to provide protection against erosion in the channel upstream from the terminal structure. If the grass lining is not dependable, there would be no point in using a terminal structure because the spillway could still fail from erosion above the structure. Again, the exploration of this idea is left for future consideration.

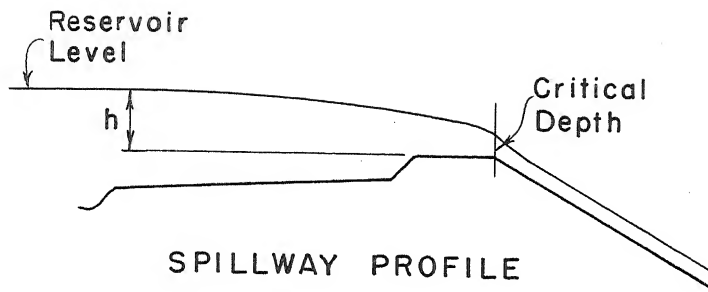
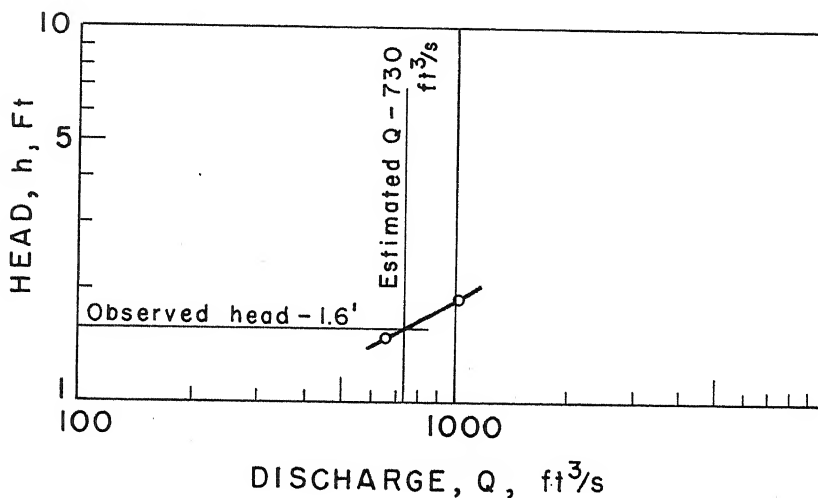
FIGURE A-1.—Rating curve for site 24 emergency spillway and estimated discharge for the flow event of October 10-11, 1973.

During the storm the water surface in the reservoir rose to a peak of 1.6 feet above the emergency spillway crest. The flow rate at this head is estimated to have been 730 cubic feet per second. (The procedure for making this flow estimate is given in appendix A.)
